## Exhibit D

SEVEN YEAR DATA FOR TEN YEAR PROLENE<sup>™</sup> STUDY: ERF 85-219  
-----

**Interim report on the physical testing of PROLENE, PVDF, ETHILON & NOVAFIL after seven year subcutaneous implantation in the Beagle Dogs - TEN YEAR BSR STUDY, ST#E211-92, 85-219**

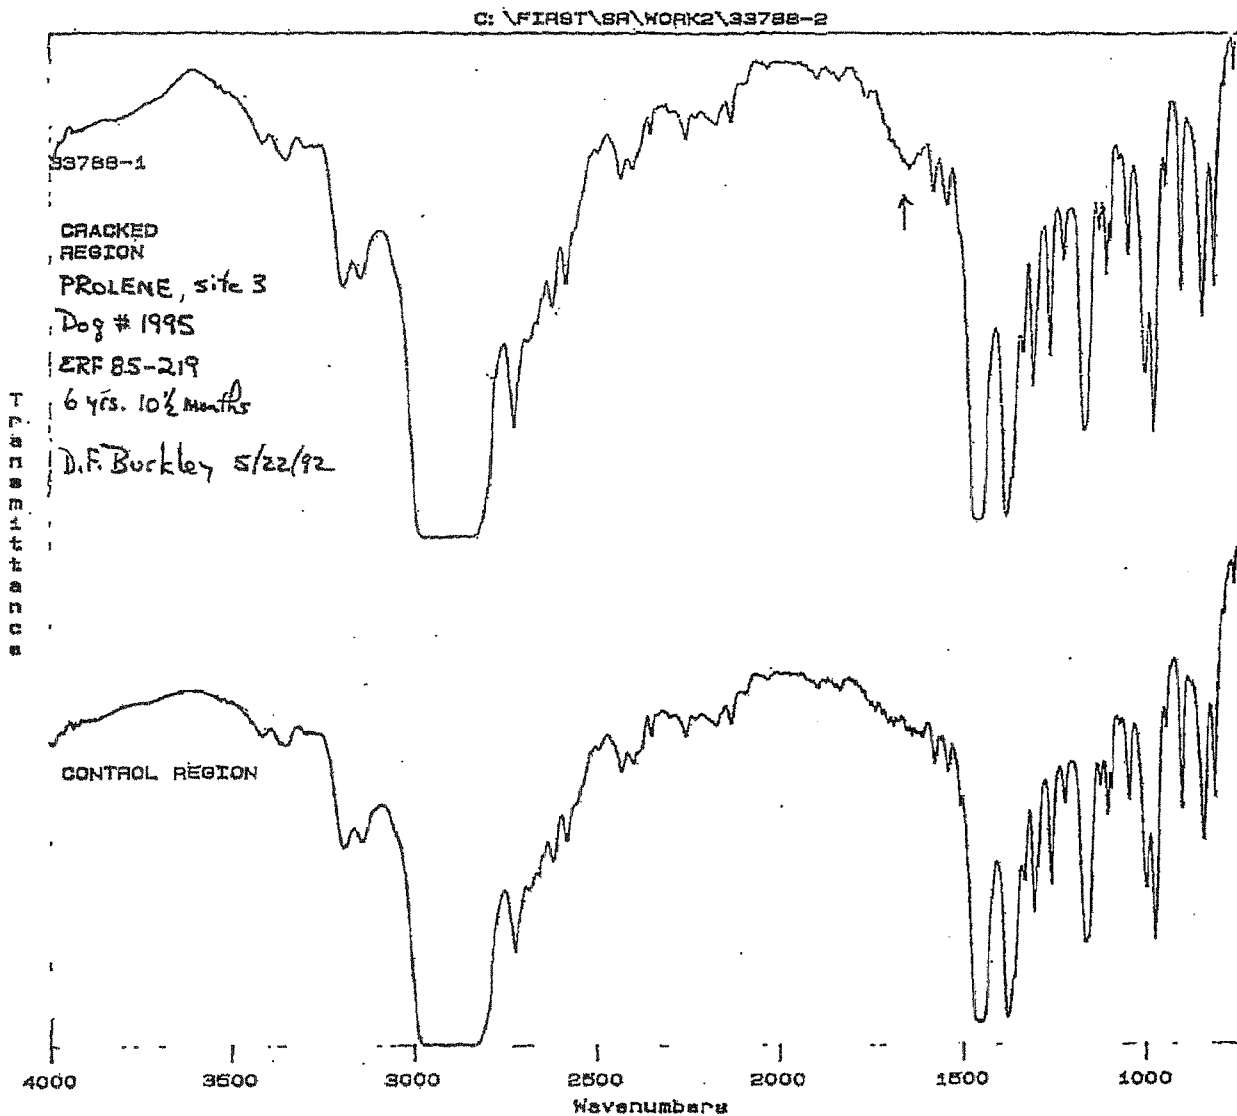
Figure A - Comparison IR Spectra of Cracked and Non-cracked Regions of PROLENE (SR33788)

IR microspectroscopy was used to examine cracked areas in ETHILON, Novafil and PROLENE<sup>™</sup> explants. IR spectra obtained for cracked PROLENE specimens (Figure A) showed possible evidence of slight oxidation (a broadened weak absorbance at about 1650 cm<sup>-1</sup>). IR spectra obtained for cracked areas of ETHILON and Novafil did not differ from uncracked areas (Figures B and C), but expected IR absorbances for oxidation would be masked by the strong carbonyl absorbances normally observed for these sutures. Figures D and E show pictures of the areas examined by IR microspectroscopy for ETHILON and Novafil.
